Memorandum

From: Mitchell Jackman; Adam Crary, PWS, PWD Re: Section 248 Natural Resources Assessment

**Representative Natural Resource Assessment Photographs
Shaftsbury Solar Project
Shaftsbury, Vermont**

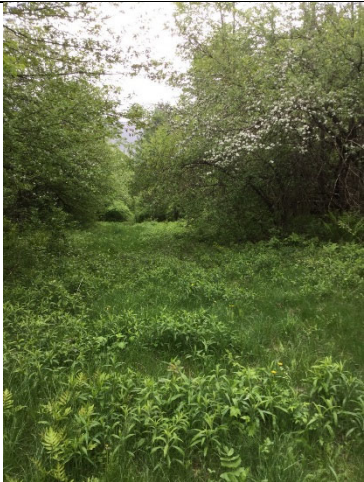
<p>Photograph 13. Representative view of unmanaged orchard found south of the site access road</p>		<p>Photograph 14. Representative view of the regenerating forested area near the old orchard below site access road</p>

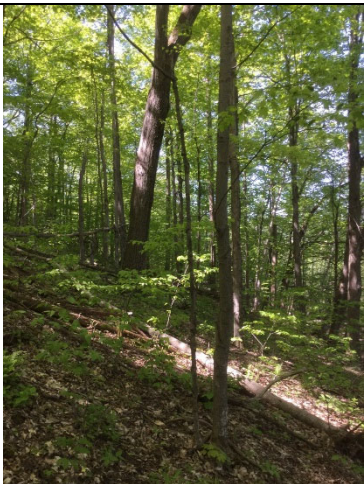
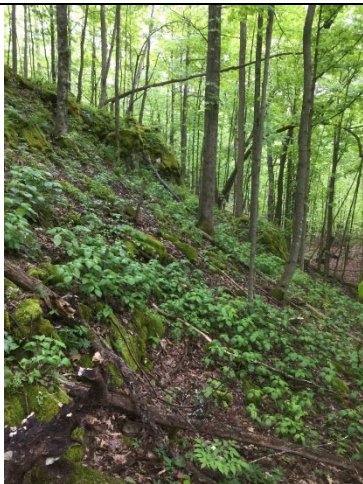
<p>Photograph 15. Representative image of the Dry Oak Maple Limestone Forest natural community</p>		<p>Photograph 16. Representative image of the Dry Oak Maple Limestone Forest natural community</p>

The identified DOMLF is found on very shallow steeply sloped areas of the site. The areas has some signs of fire wood harvest but it seems largely undisturbed, it has multiple age class overstory with many mature trees present, few shrubs and a dense herbaceous layer with few occurrences of invasives. There is standing dead trees and moderate course woody debris. The canopy is comprised of *Acer saccharum*, *Carya cordiformis*, *Ostrya virginiana*, *Quercus rubra*, *Fagus grandifolia*, *Fraxinus americana*, *Betula papyrifera*, and *Tilia americana*. The shrub layer includes *Hamamelis virginiana*, *Viburnum acerifolium*, *Sambucus racemose*, the herbs layer was very dense and included *Adiantum pedatum*, *Cystopteris bulbifera*, *Carex platyphylla*, *Thalictrum dioicum*, *Asarum canadense*, *Anemone acutiloba*, *Conopogon americanus*, *Solidago flexicaulis*.

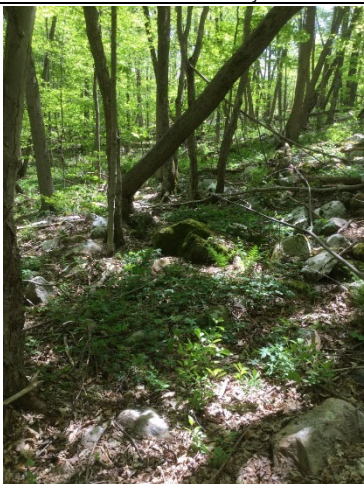
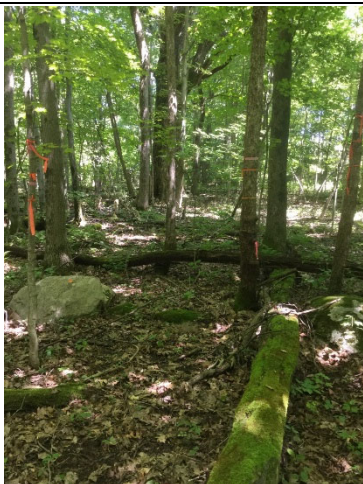
<p>Photograph 17. Representative image of the Rich Northern Hardwood Forest natural community</p>		<p>Photograph 18. Representative image of the Rich Northern Hardwood Forest natural community</p>

Mapped in shallow soils areas found vegetative composition to be similar to RNHF. The Community shift corresponds with the soils and bedrock geological transition. RNHF *prunus serotina* *Laportea canadensis*, *hydrophyllum virginianum*, and *geranium robertianum* were more common.

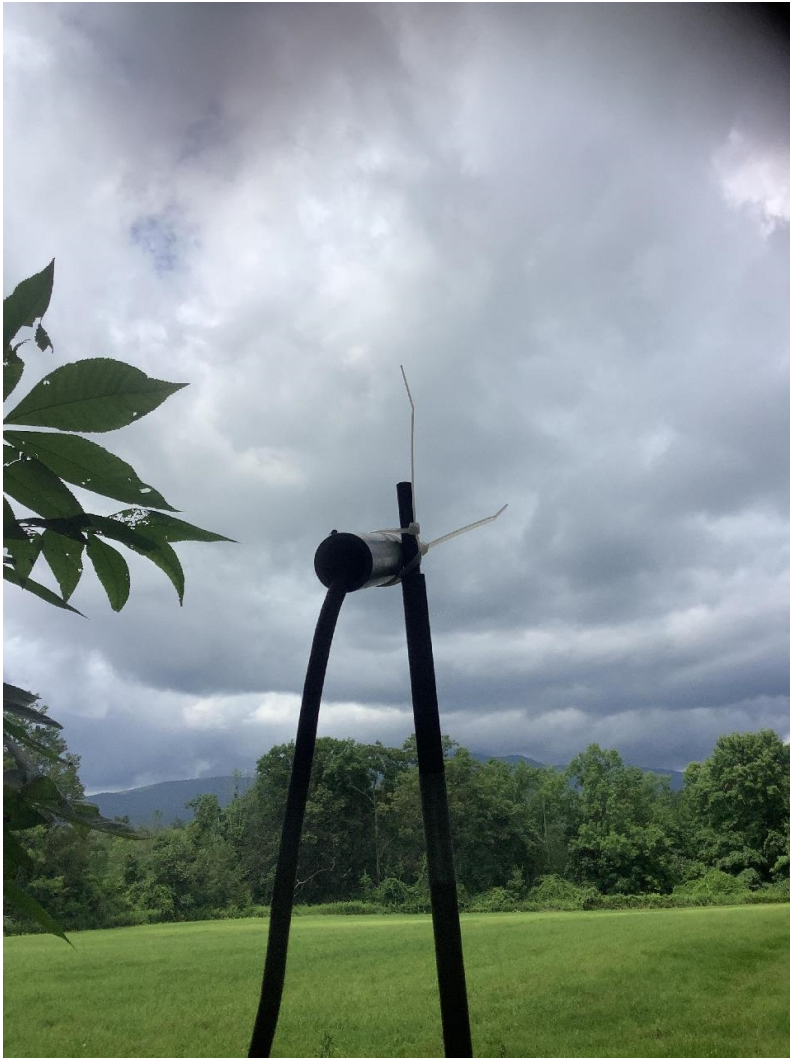
Cone of detection

Microphone facing north targeting flyway over hayfield

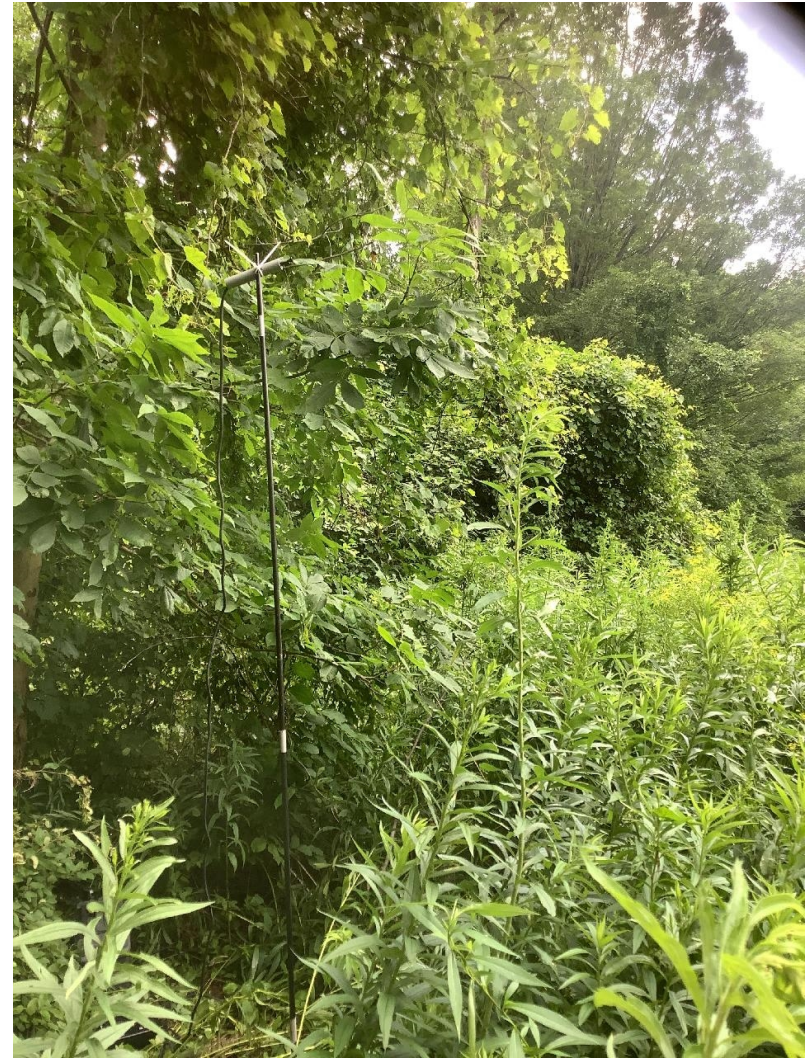
Microphone setup

Detector positioned on forested edge of hayfield

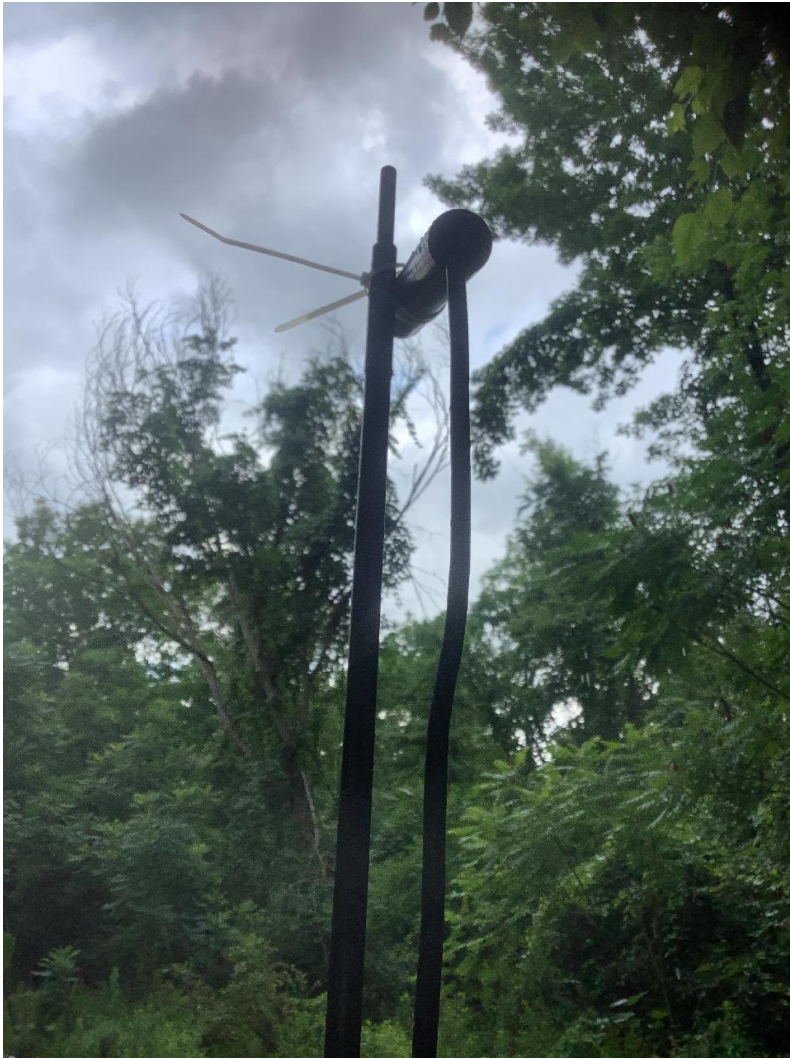
Cone of detection

Microphone facing west targeting flyway over access road

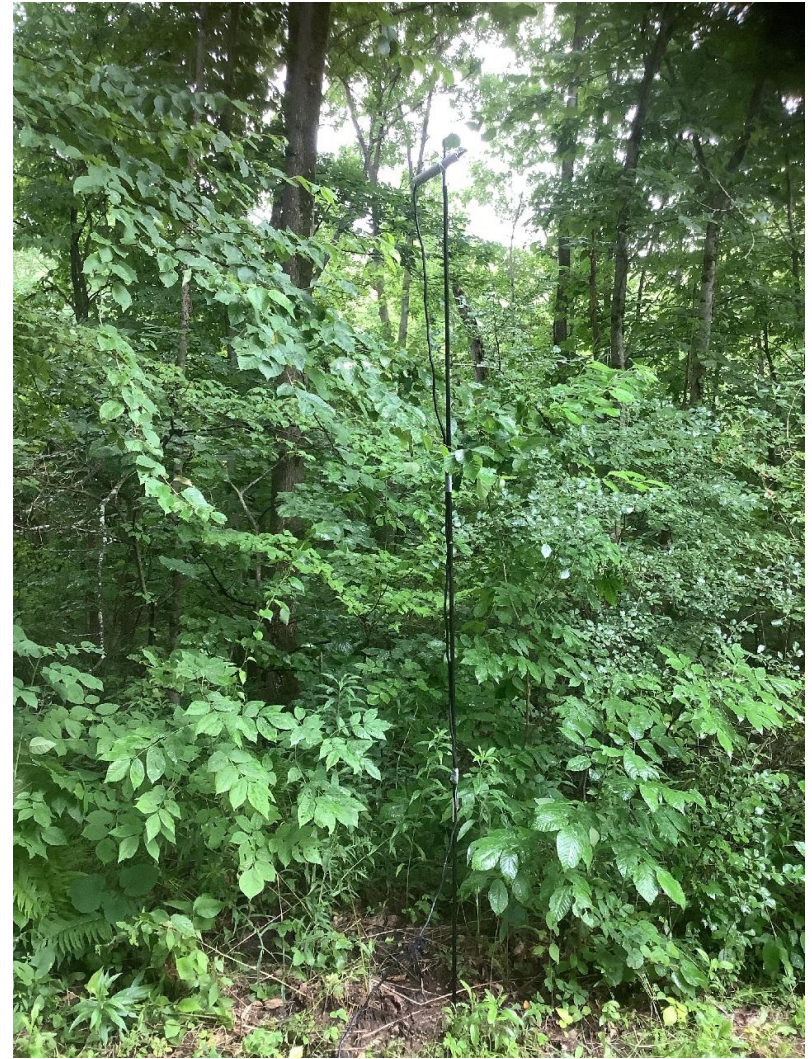
Microphone setup

Detector positioned on edge of access road within upland deciduous forest

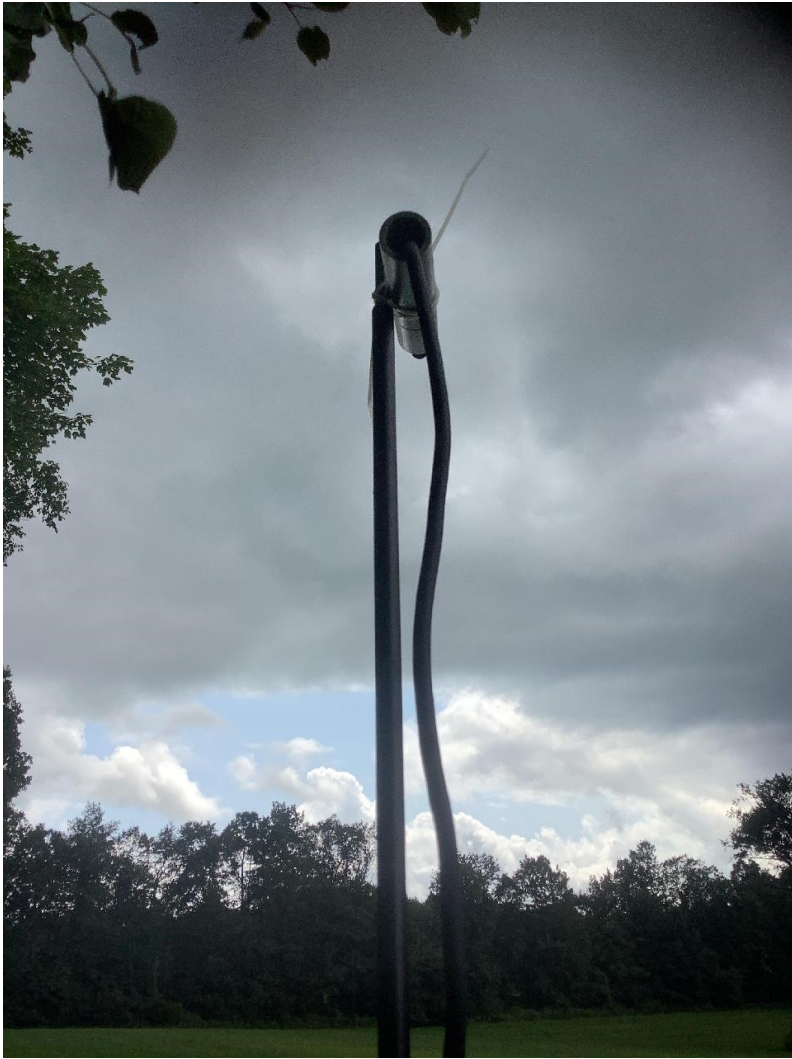
Cone of detection

Microphone facing southwest positioned to target the flyway over the hayfield

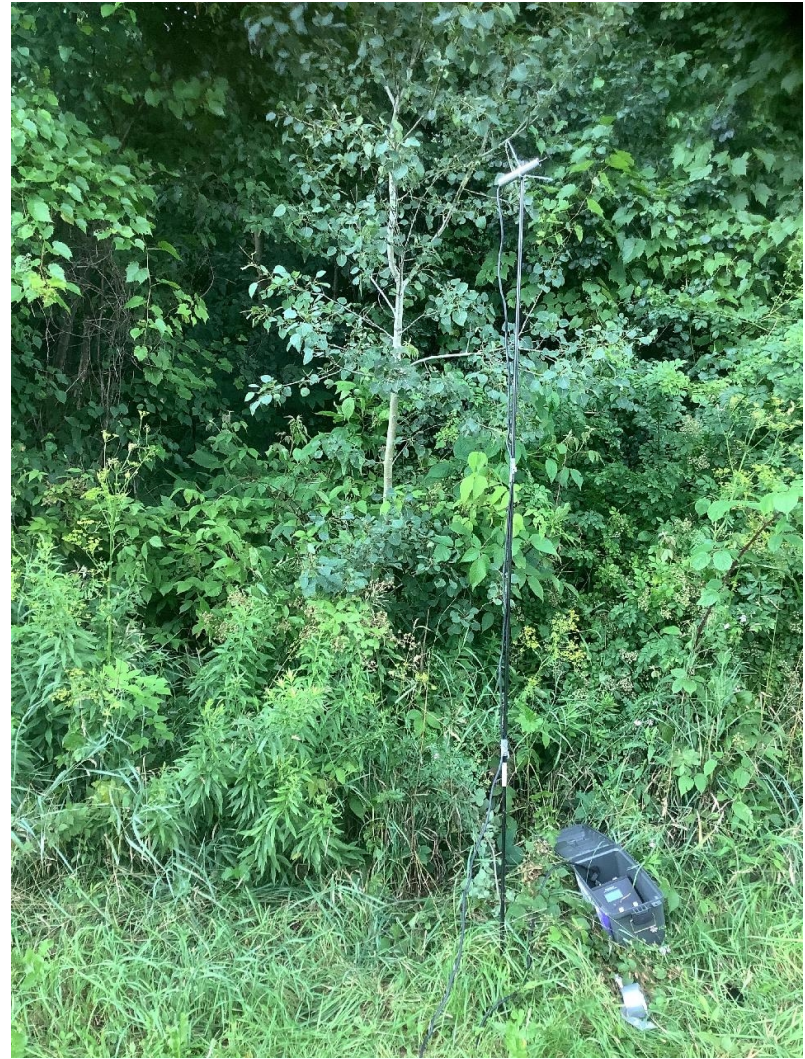
Detector setup

Detector located on edge of maintained hayfield adjacent to upland forest

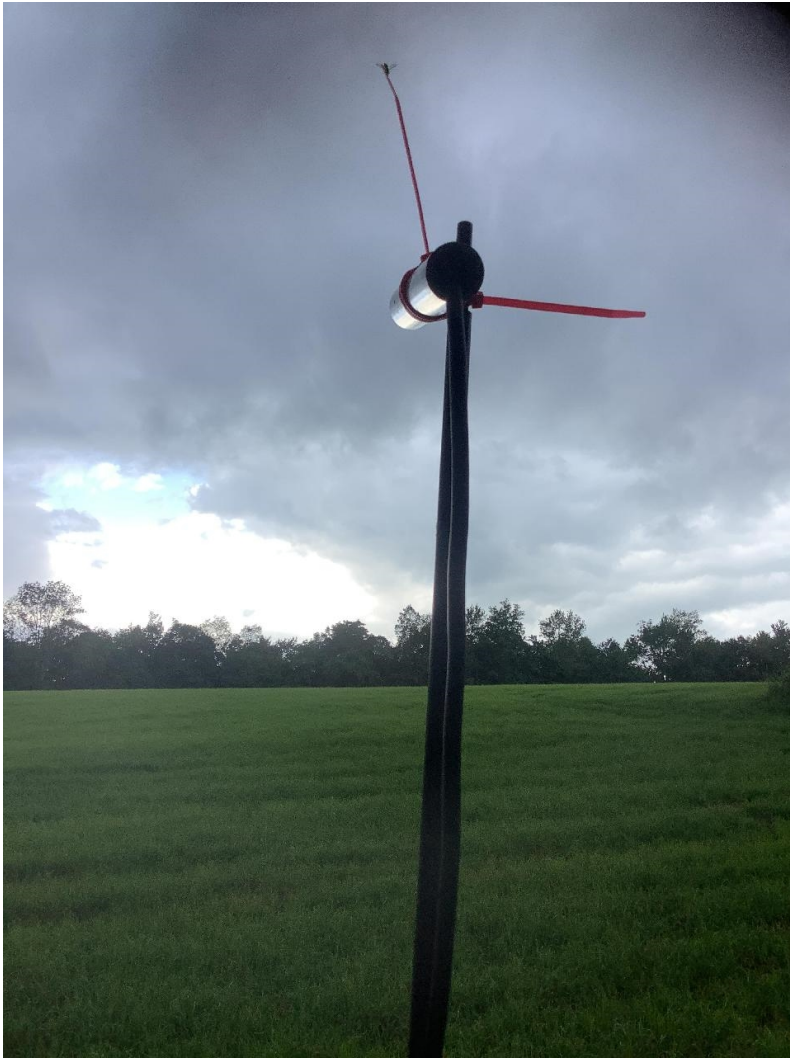
Cone of detection

Microphone facing west positioned to target the flyway over the mainland hayfield

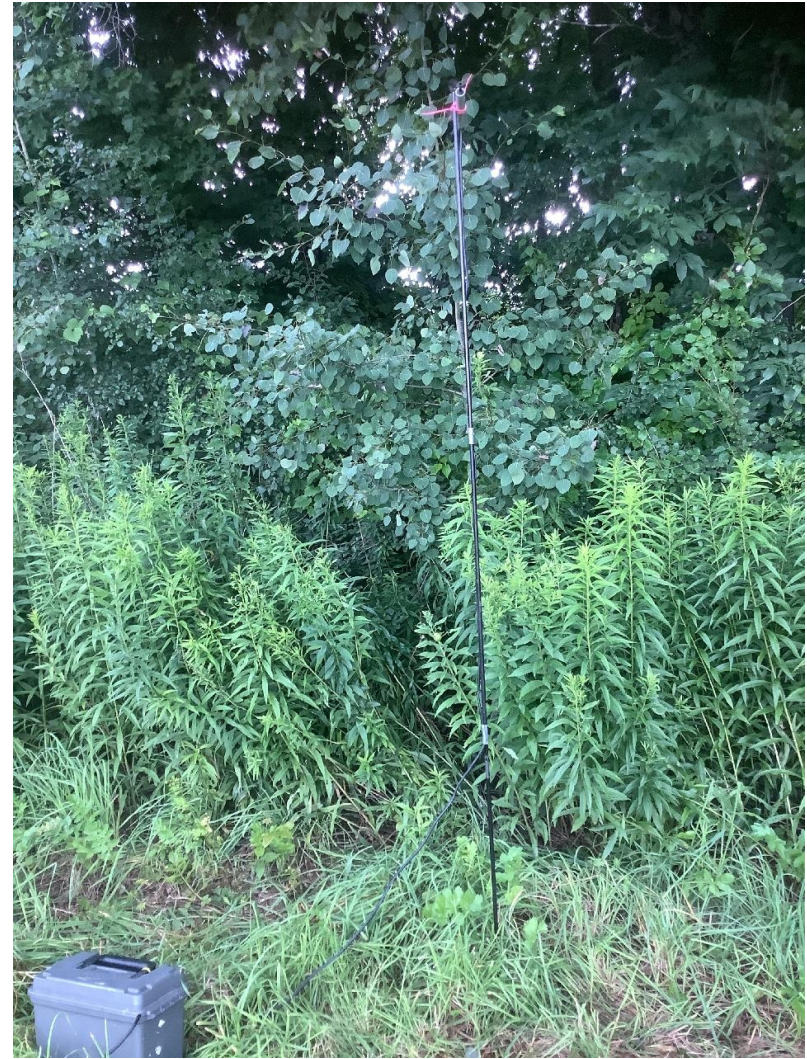
Microphone setup

Detector located on edge of maintained hayfield adjacent to upland forest
